Subject: December 2012 Monthly Progress Report at Schaefer Road Waste Water Treatment Plant ('SRWWTP')

MONTHLY PROGRESS REPORT
FOR
December 2012

SCHAEFER ROAD WASTE WATER TREATMENT PLANT

SEVERSTAL DEARBORN

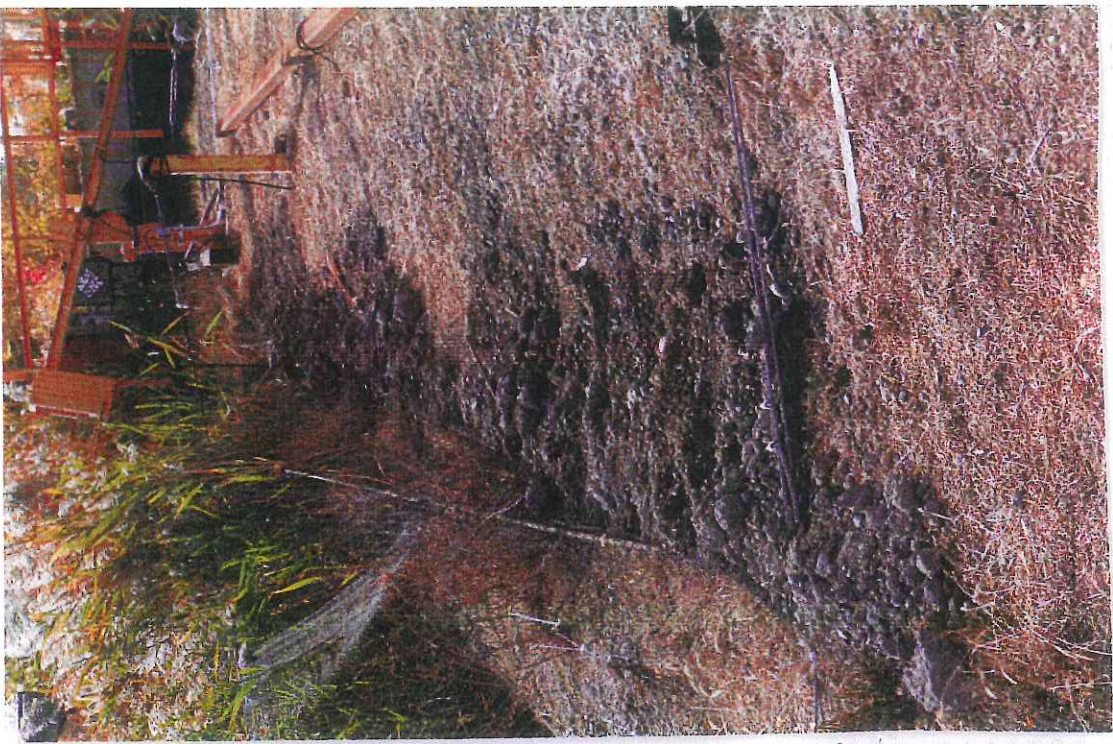
#3: West Sludge Pond, looking west from approximately 30 feet north of Brill skimmer tank. Note netting, spacer drums, and west perimeter fence in-place. Rouge River floodplain beyond fence in background.

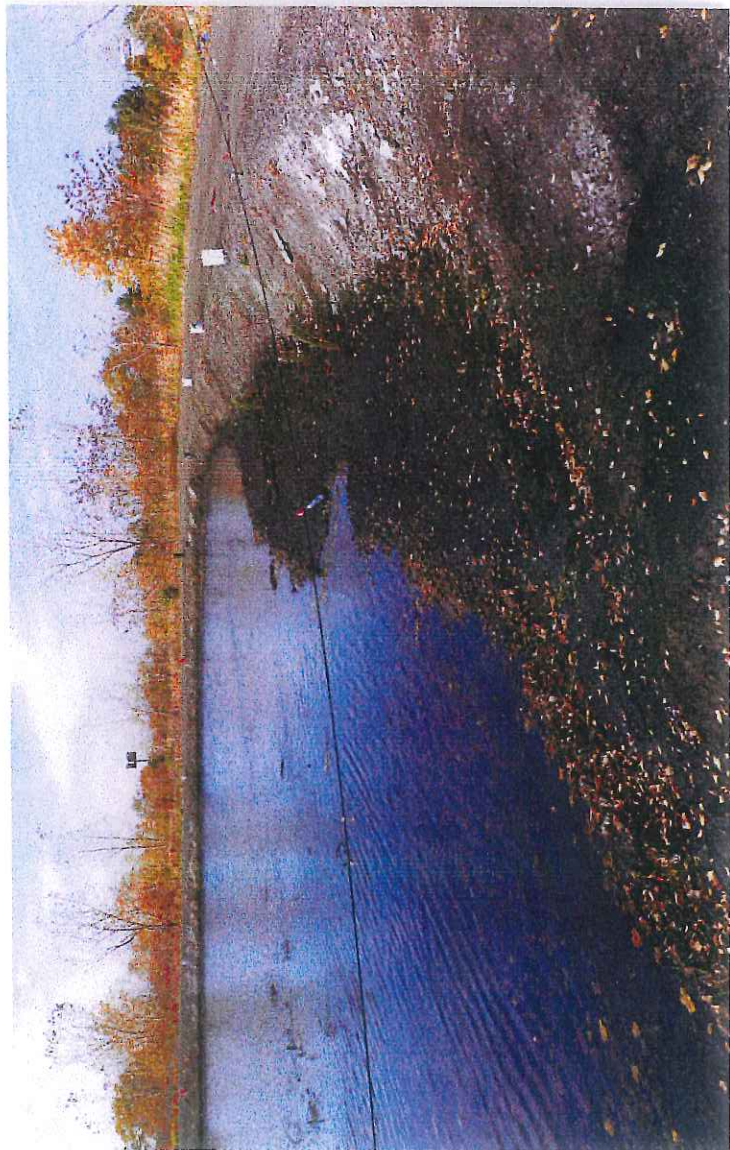
#9: East side of Diked Lagoon, looking north from approximately 15 feet north of Station No. 4 at the southeast corner of the lagoon. Note Mylar ribbons in-place, and littoral area. Bermed area proper in background..

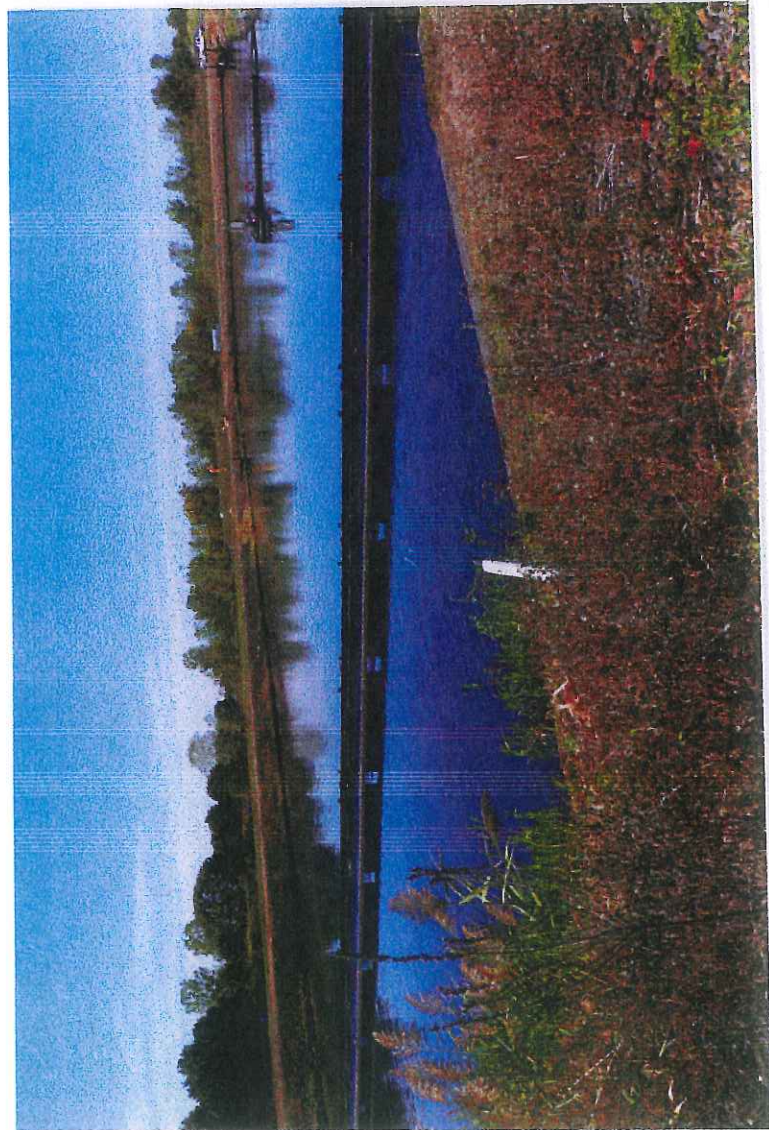
#9: East side of Primary Lagoon, looking north from approximately 5 feet north of the southeast corner of Primary Lagoon fence. Note Primary Lagoon fence and air-dancer in-place; baffle and weir, OMI 1, and TVT.

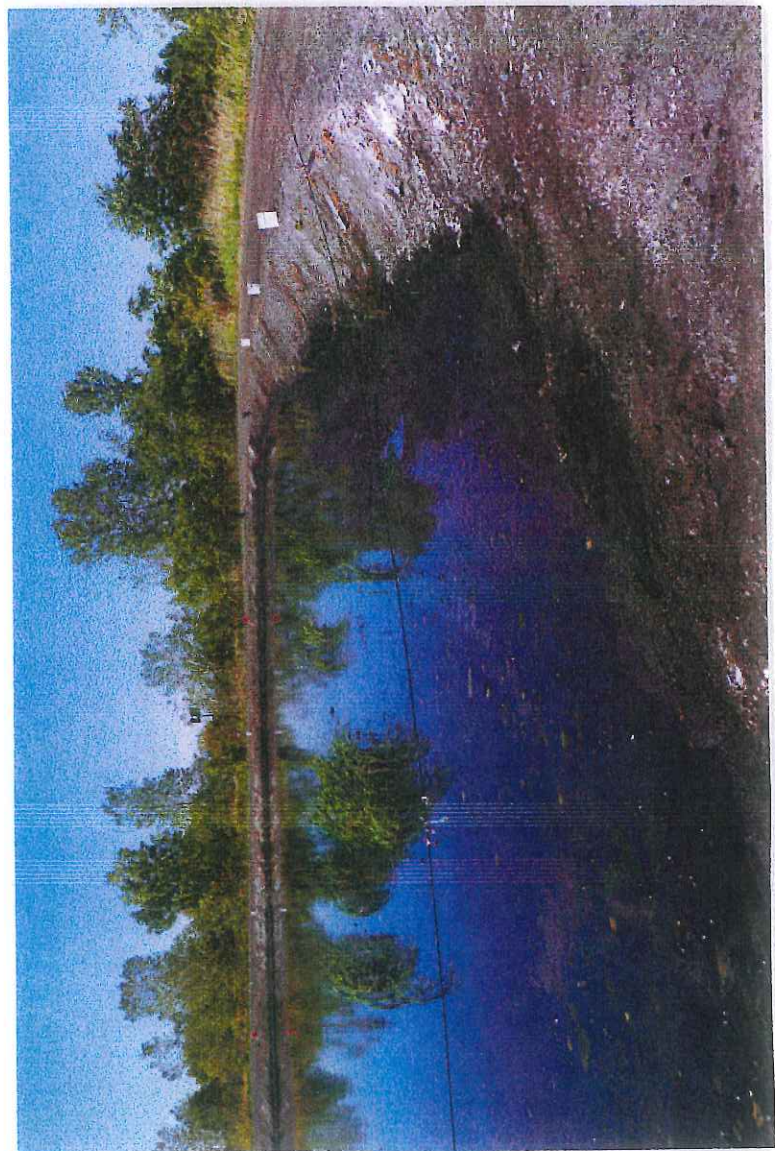
#6: Diked Lagoon, looking west from Station No. 4, located opposite the southeast corner of the lagoon. Note propane cannon in-place and cabling for Mylar ribbons. Dogleg of bermed area in left background.

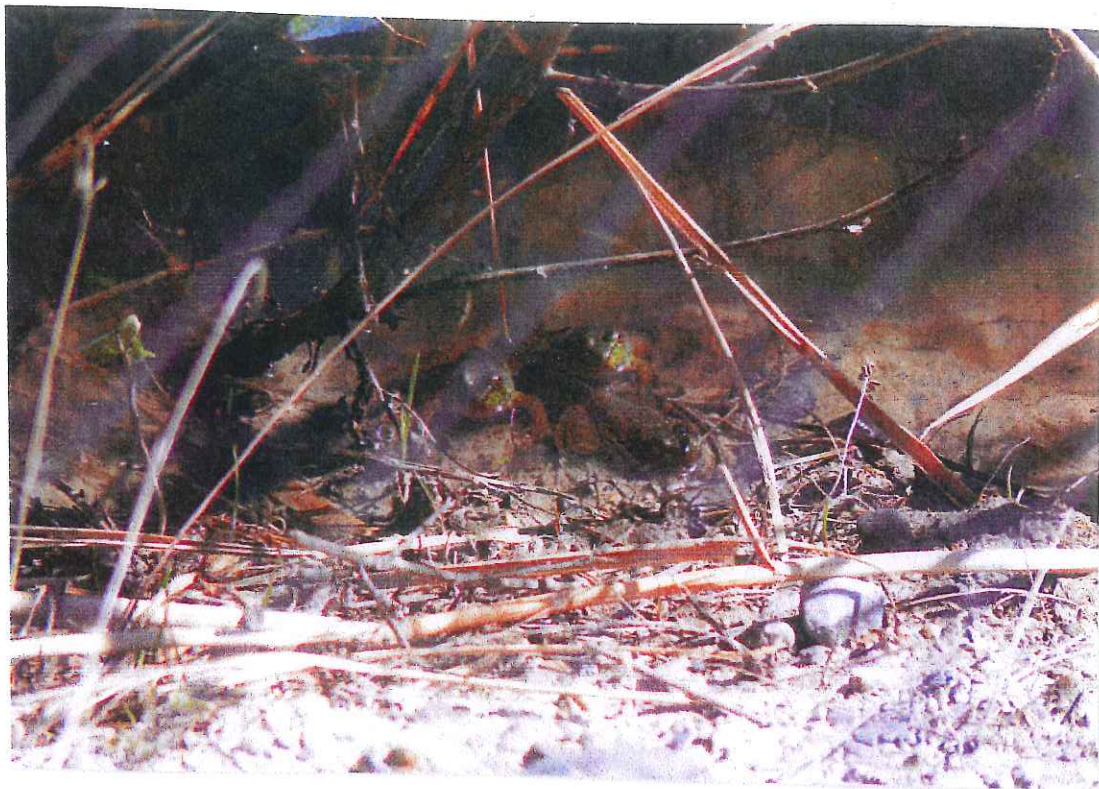
#3: West Sludge Pond, looking northwest from approximately 35 feet north of skimmer tank. Note netting, spacer drum (far left), and west perimeter fence in-place.

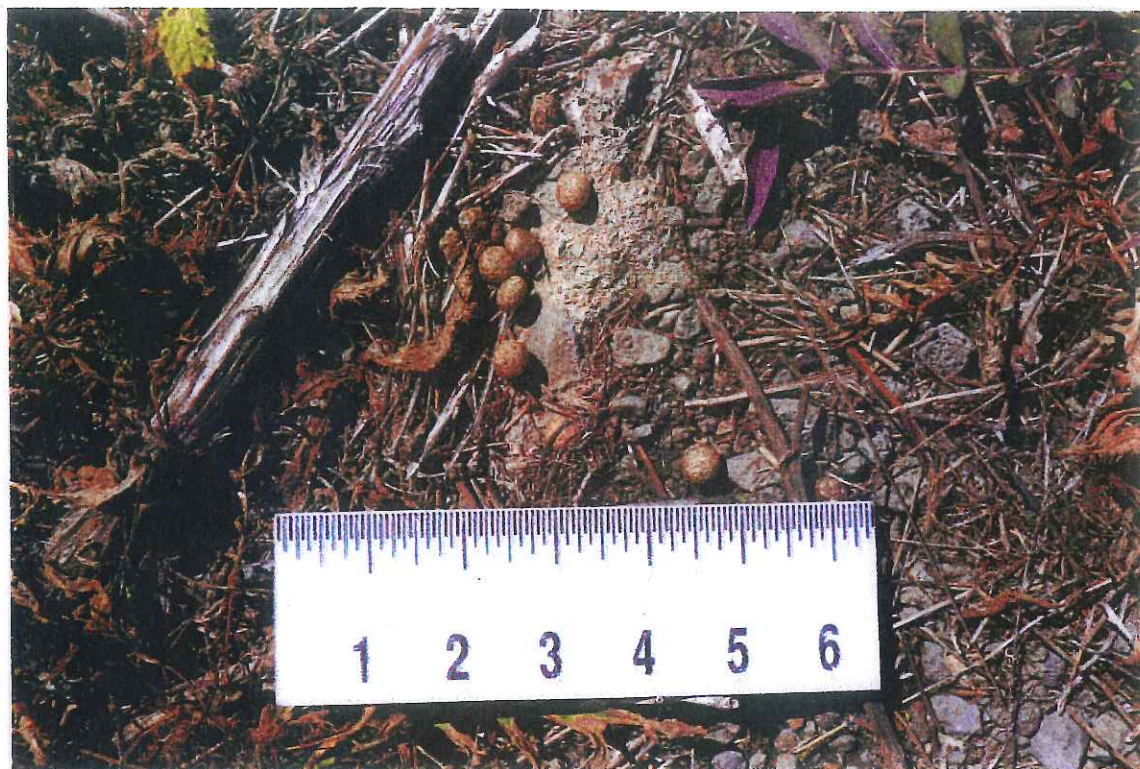
#12: North end of Primary Lagoon, looking east-northeast from under the net approximately 4 feet north of the west three feet of the OMI 2 mop tray. Note netting in-place.

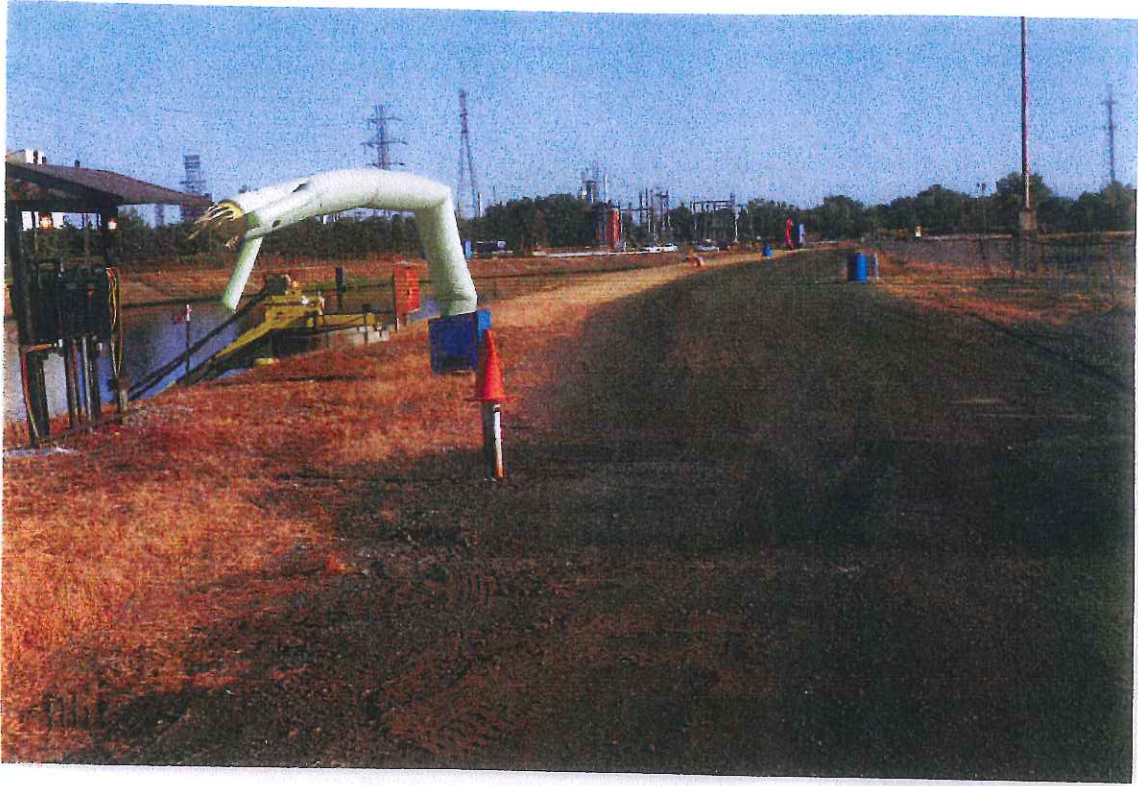
#15: Ground at west shoulder of road west of Diked Lagoon directly opposite the intersection of the roads west and south of the Diked Lagoon, looking down and west. Note Coyote scat and inch ruler for scale.

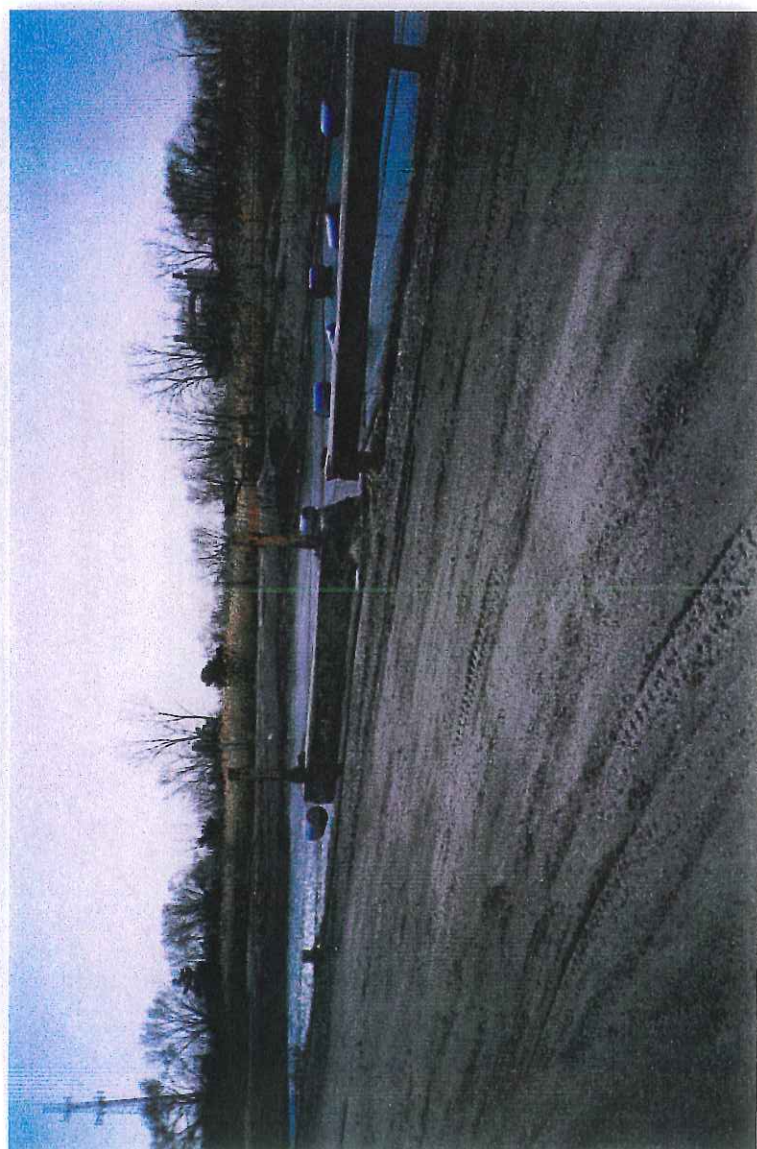
#3: Ground at top of east central bank of East Sludge Pond opposite north end of former loading pad, looking down and west. Note Eastern Cottontail carcass, as found, entangled in excess netting.

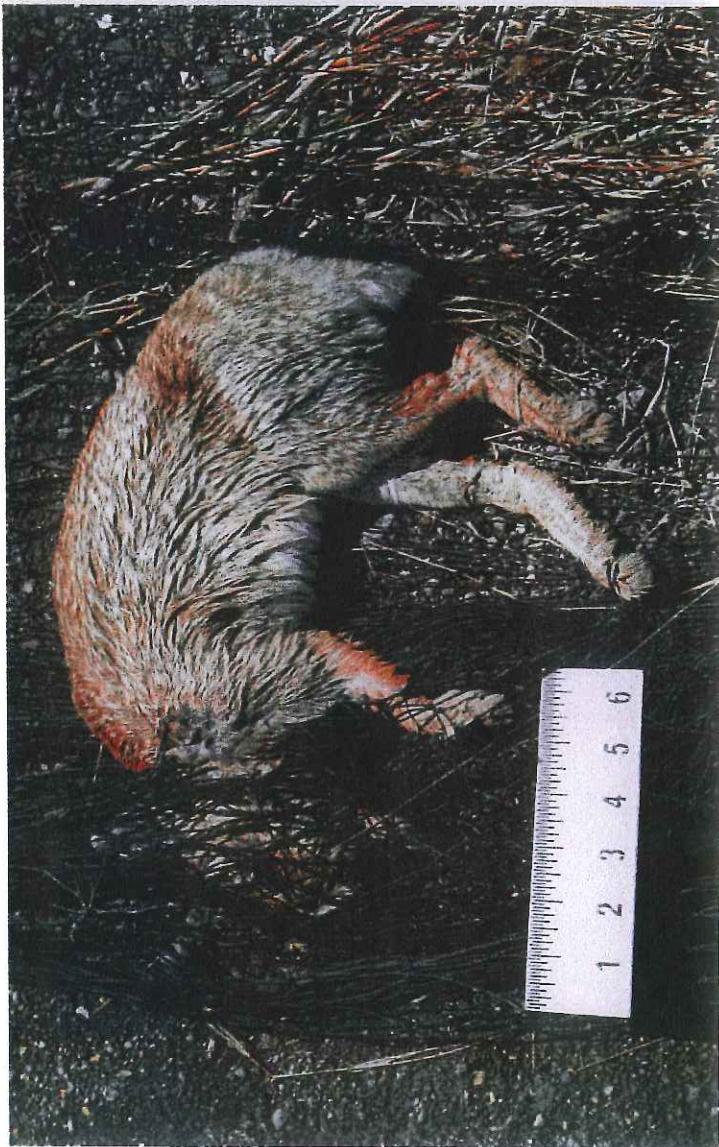
#6: Close-up of head of Eastern Cottontail carcass, as found, looking down and south. Note netting wrapped tightly around neck, open eye, long rabbit-like ears, and Greenbottle Fly on chestnut nape.

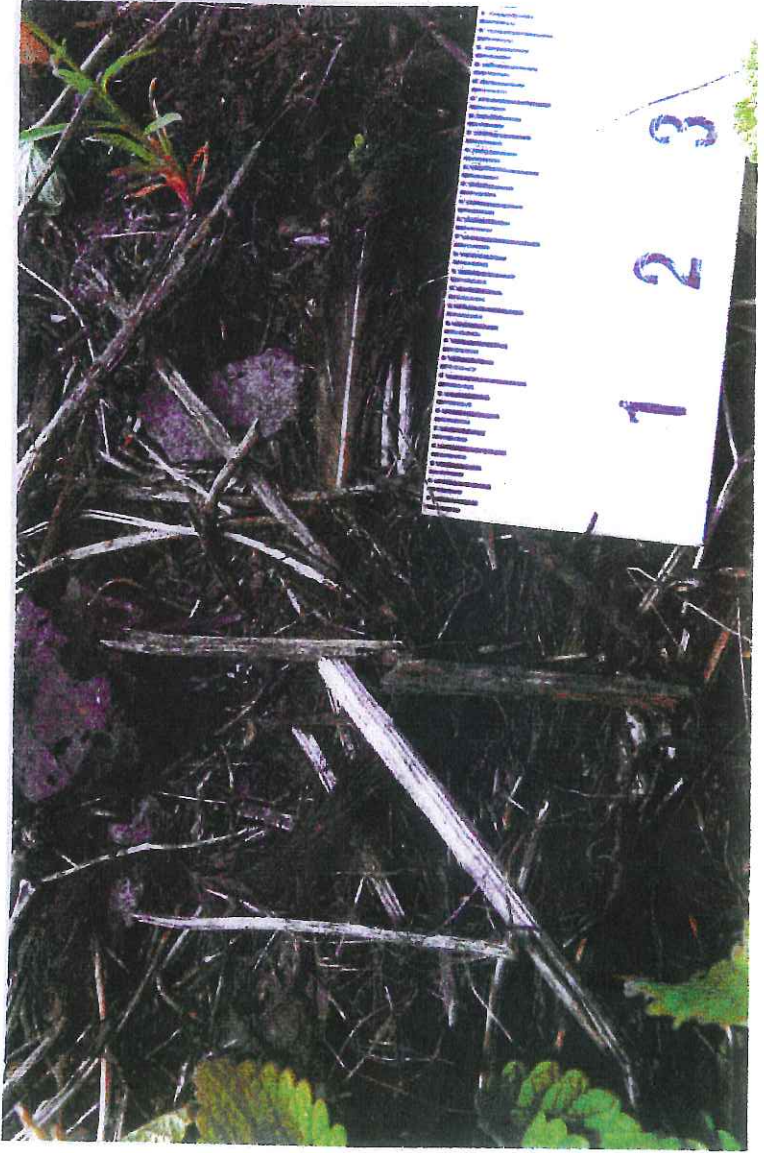
#3: Ground of middle slope of east bank of Primary Lagoon, looking down and southeast. Note Mallard remains, specifically feathers protruding from ground and inch ruler for sizing. Note extreme weathering of feathers.

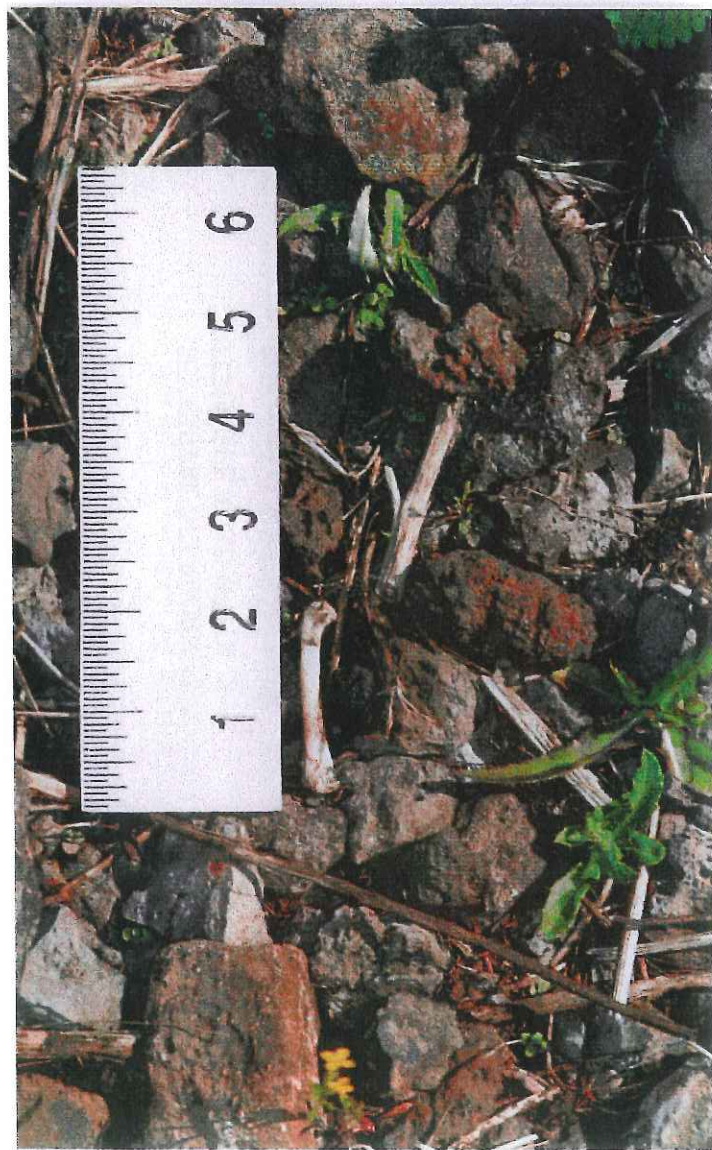
#6: Ground of middle slope of east bank of Primary Lagoon, looking down and southeast from approximately 10 inches northwest of Photo #3. Note Mallard remains, specifically bones and feathers and inch ruler for sizing.
